Name: OLD COLUMBIA PIKE OVER TIBBOL RIVER / HO-132

MARYLAND INVENTORY OF HISTORIC BRIDGES
HISTORIC BRIDGE INVENTORY
MARYLAND STATE HIGHWAY ADMINISTRATION/
MARYLAND HISTORICAL TRUST

SHA Bridge No. HO-132 Bridge name Old Columbia Pike over Tiber River

Bridge Type CONCRETE BEAM
Map Baltimore SW D-12
County HOWARD HO-680
Bridge # and name HO-132
Old Columbia Pike over Tiber River

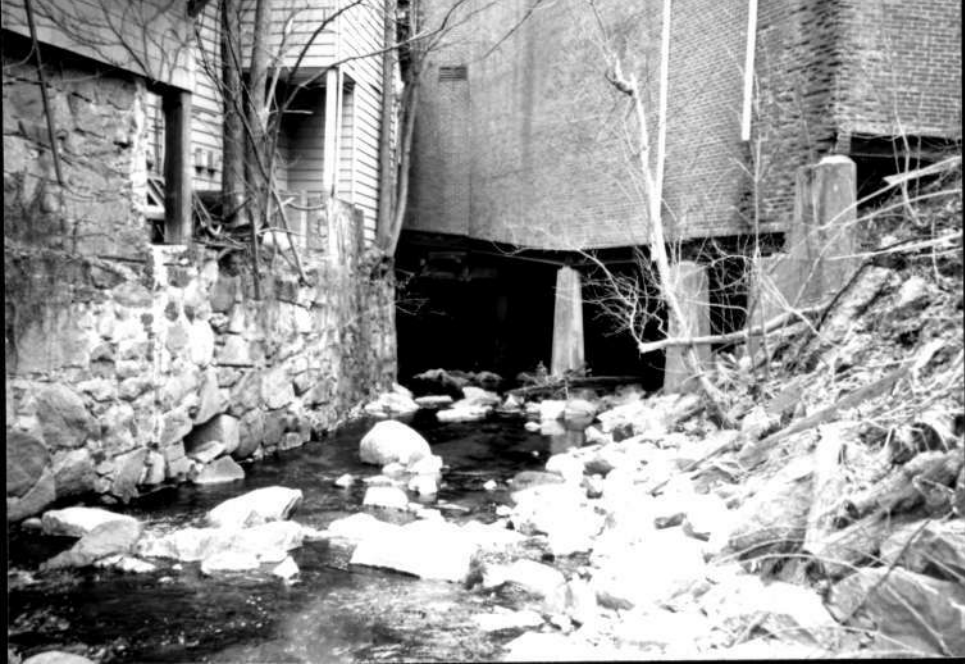
1. HO-680
2. (HO-132) Old Columbia Pike over Tiber River
3. Howard Co. M.D.
4. Tim Tamburino
5. 3-97
6. MD SHPO
7. West elevation
8. 3 & 4

Bridge No. HO-132 is a 1-span, 2-lane concrete beam bridge. The bridge was originally built in 1921, and widened in 1964. The structure span length is 24 feet long, with a total structure length of 26 feet. Immediately adjacent to the west side of the bridge is a steel-framed section supported by masonry abutments and concrete columns previously used to support an automobile service station. In 1964, the station was demolished and the roadway over the T-beam section was extended over the steel-frame section. The roadway width varies from 24 feet on the south approach to 104 feet at the intersection with Main Street. The superstructure consists of five (5) concrete beams which support an integral concrete deck with a bituminous wearing surface. The substructure consists of masonry abutments. There are no wing walls. The bridge is posted for 3/4 tons on the north approach and 14 tons on the south approach. The bridge has a Howard County sufficiency rating of 63.6.

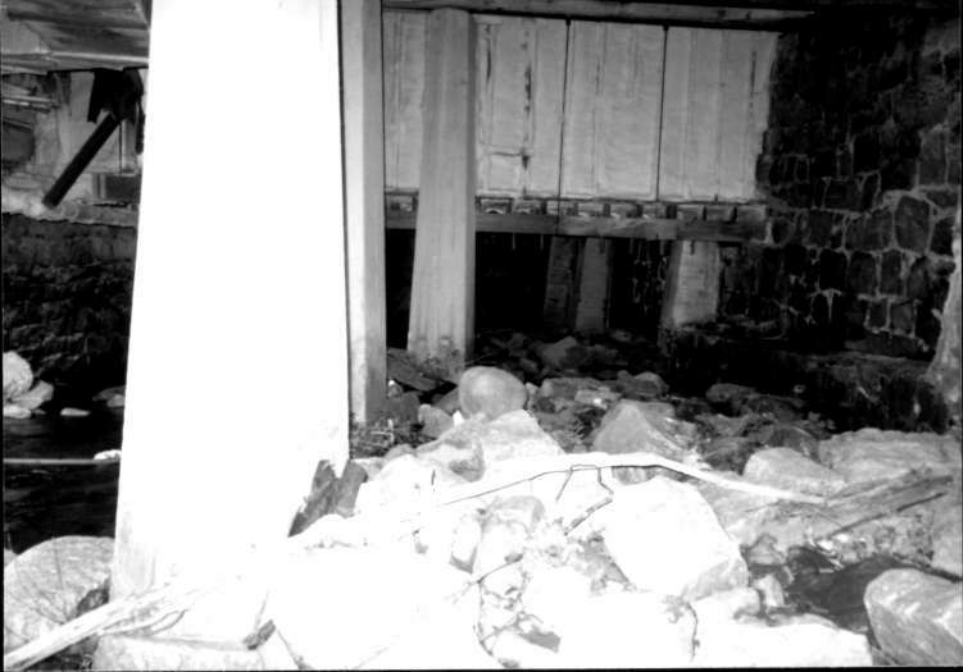
1. HO-680
2. (HO-132) Old Columbia Pike over Tiber River
3. Howard Co. M.D.
4. Tim Tamburrino
5. 3-97
6. MD SHPO
7. Underside of deck
8. 4 of 4

According to the 1996 inspection report, this structure was in fair condition with spalling and section loss. Spalling with exposed reinforcement bars are evident on some T-beam flanges and stems. The steel beams have areas of corrosion with five (5) to fifteen (15) percent section loss. The stone masonry abutments are in generally good condition.

The bridge was first widened onto a steel frame supporting structure in 1964. In 1983, and again in 1993, extensive repairs were made to the concrete and stone masonry of the bridge.
